# Stress-corrosion studies on materials used for surgical implants\*

by C. R. THOMAS†  
and F. P. A. ROBINSON°

Samples of Vitallium (a cobalt-chromium alloy), 316L stainless steel, and titanium T318 were subjected to the boiling magnesium chloride test so that their susceptibility to stress-corrosion cracking could be determined, and their behaviour under service conditions was then assessed.

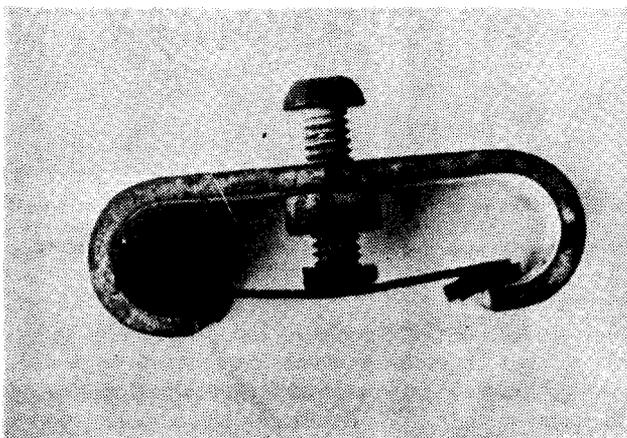
Fig. 1—Jig used for the stressing of specimens, showing the rubber insulation in position

where  $\sigma$ =tensile stress,  $E$ =Young's modulus,  $t$ =thickness of sample,  $y$ = maximum deflection, and  $L$ =distance between supports. By tightening or loosening the bolt-nut combination, the stress could be varied at will.

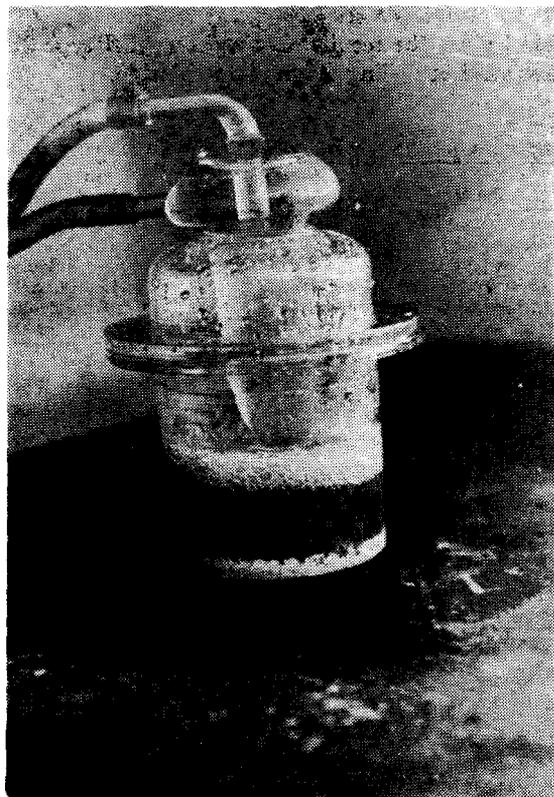
Fig. 2—Pyrex container used in the boiling magnesium chloride tests, with the finger-type reflux condenser in position

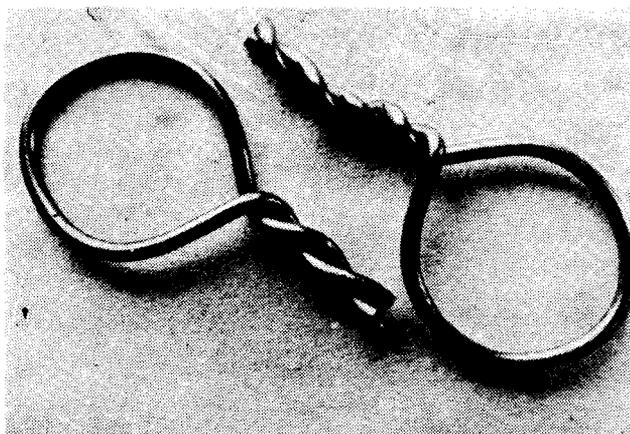
Fig. 3—Two of the wire loops submitted to the boiling magnesium chloride tests

A brief test was conducted on small twisted wire loops (Fig. 3) of all the biometals immersed in boiling magnesium chloride. The loops were removed every half hour, studied under a hand lens, and re-immersed until failure occurred.

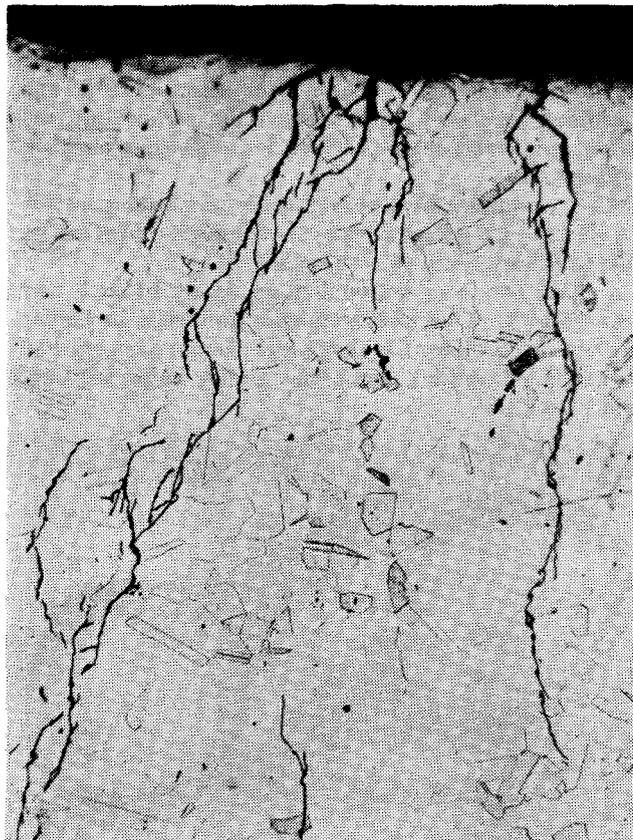
Fig. 4—Transgranular cracks in sample 1 (solutionized 316L stainless steel) after the boiling magnesium chloride test (electrolytic oxalic,  $\times 240$ )

Fig. 4 shows the cracks in one of the samples before etching, the jagged surface and branching cracks being indicative of stress-corrosion cracks in stainless steel. The fracture surface also showed these small branching cracks. After etching, all the cracks were confirmed as transcrystalline. In sample 4, one crack was generally transgranular, but a small section appeared to be intergranular (Fig. 5). The explanation for this, as given by Edelenau<sup>17</sup>, is that such cracks can result from the coalescence of numerous short transgranular cracks across the grain boundaries.

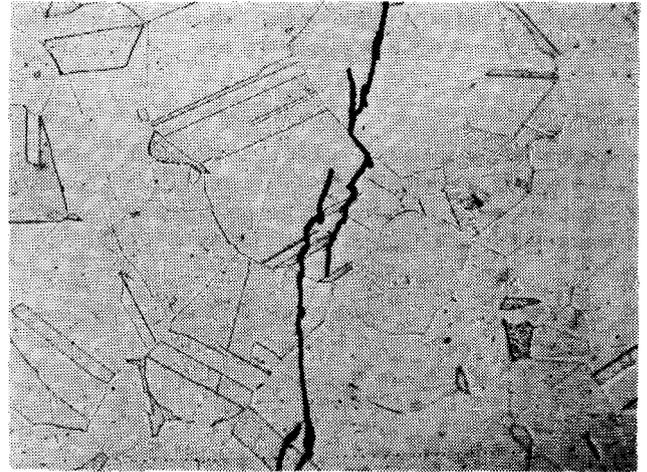
Fig. 5—Cracks in sample 4 (cold-worked 316L stainless steel) after the boiling magnesium chloride test; one of the cracks at the centre is intergranular and the other is transcrystalline (electrolytic oxalic,  $\times 450$ )

The cold-worked samples (3 and 4), when stressed to the same level of stress as the solution-treated plates (1 and 2), failed in a much shorter time owing no doubt to the pernicious combination of residual and applied stress. Of critical importance is the influence of tensile strain rate upon the exchange current density of the material corroding in the crack. Since constant deflection testing was used, the parameter of strain rate was maintained constant, permitting direct comparison of the test results.

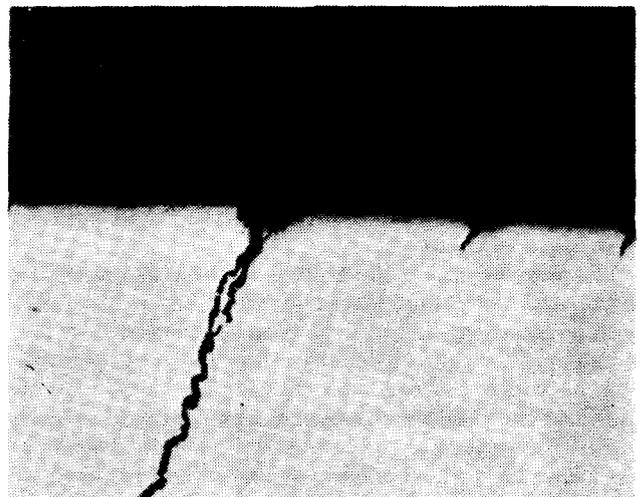
Fig. 6—A polished section of a stainless-steel loop that had been submitted to the boiling magnesium chloride test, showing cracks originating from the base of pits (unetched,  $\times 200$ )

Close examination of the coiled wire loops revealed the presence of cracks extending from the outer edge towards the inner edge. A polished section of a loop is shown in Fig. 6, and the importance of pits in the initiation of S.C.C. is obvious. Although the samples of wire and plate were all of 316L stainless steel, a range of chemical composition is allowed within the specification, and the role of pitting in the nucleation of S.C.C. may well be a function of the chemistry of the alloy. For instance, molybdenum has a beneficial effect in increasing the resistance of the passive film to pitting in chlorides.<sup>19</sup>

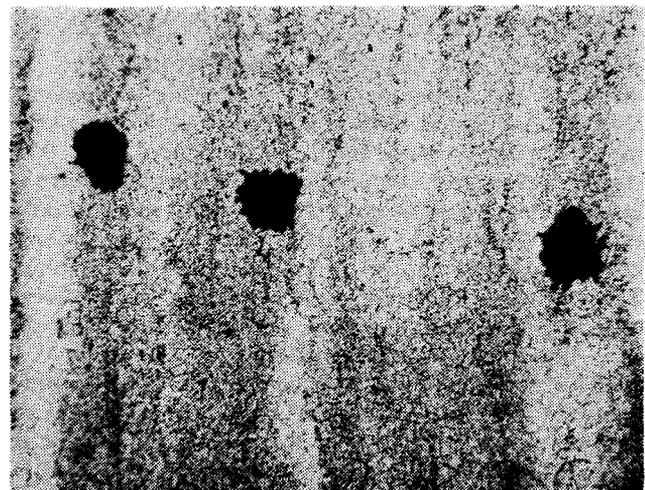
Fig. 7—Pits on a Vitallium plate that had been submitted to the boiling magnesium chloride test, showing how carbon-rich areas appear to be more prone to pitting (HCl, HNO<sub>3</sub>, acetic acid, × 180)

After the test, the surface of the wrought alloy was pitted, and microscopic examination of the surface confirmed the presence of gross pitting. The pitting appeared to be localized to regions of carbide segregation. (Fig. 7).

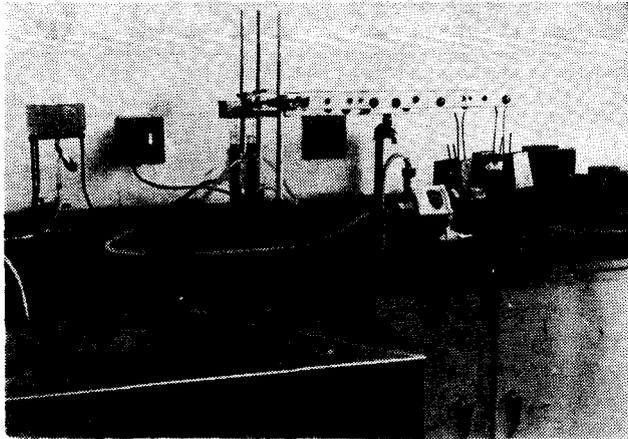
Fig. 8—The general layout of stressing levers and solution containers for the in vitro tests (the thermostatic immersion bath is in the foreground)

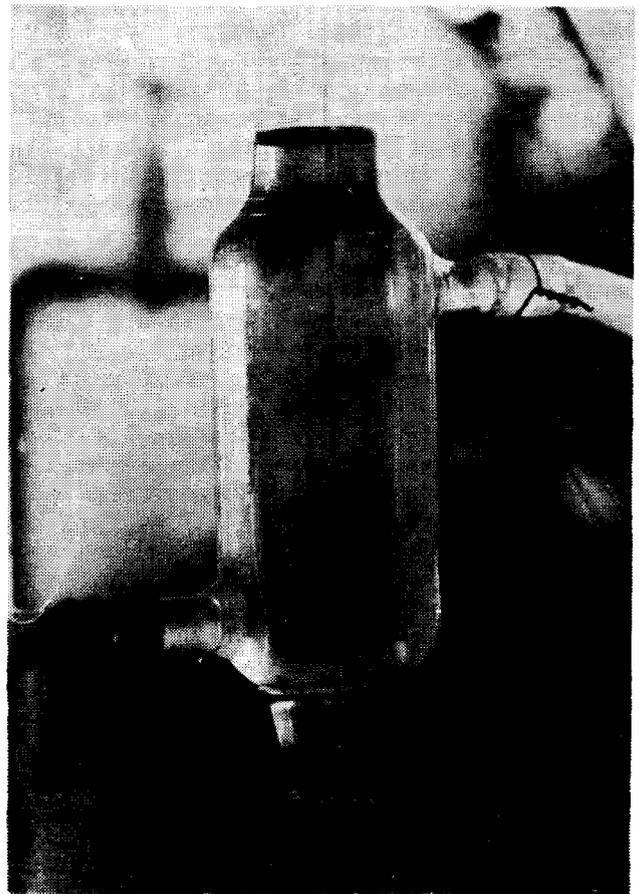
Fig. 9—Close-up of the specimen container used in the modified boiling magnesium chloride tests (the solution is placed in the inner tube while heating water is circulated in the outer jacket)

The apparatus that was used is shown in Fig. 9. The stressing rig used was the same as that in the *in vitro* tests. The flow rate of the heating water circulated through the system was 5,7 l/m, and hence the temperature obtained inside the specimen container was  $76 \pm 1,5^\circ\text{C}$ , measured with a thermometer situated in the vessel alongside the wire. The solution that lay above or below the jacketed portions of the vessels was obviously colder than the central portion and caused slow convection currents to occur. These were easily detectable with potassium permanganate crystals. An air trap had to be incorporated into the system to prevent steam from filling the pump and causing stagnation of the solution.

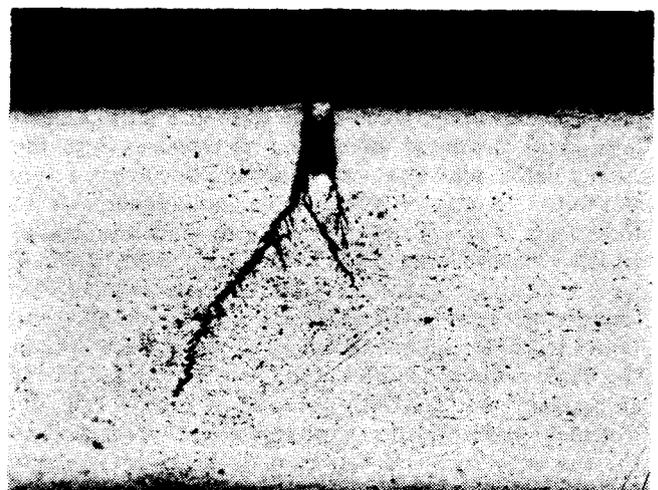
Fig. 10—Crack associated with a surface pit in 316L stainless steel that had been submitted to the modified boiling magnesium chloride test ( $\text{HNO}_3$ ,  $\text{HCl}$ ,  $\times 120$ )

Microscopic examination of the corrosion test samples, indicated that the majority of the cracks could be attributed to some surface defect, mostly pits (Fig. 10). The role of surface imperfections, noted by Rentle and Greene<sup>20</sup>, is once again exemplified. Avoidance of these surface defects would reduce the occurrence of failures most drastically. This is an area where liaison with the manufacturer could lead to marked improvements.

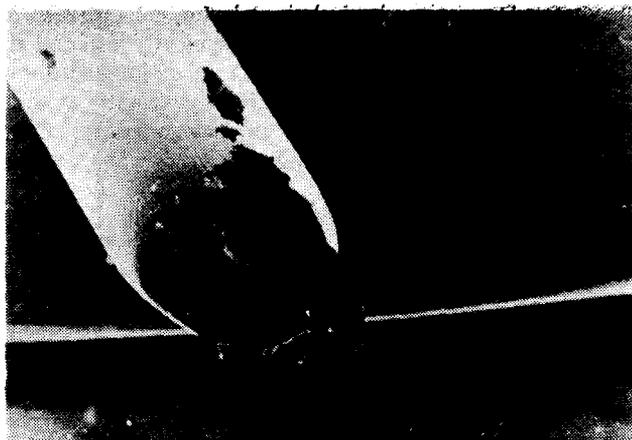
Fig. 11—The fracture surface of stainless-steel wire that had been submitted to the modified boiling magnesium chloride test, showing longitudinal pits in the wire, which may have led to premature fracture ( $\times 38$ )

One sample showed very interesting pits on the wire surface below the fracture (Fig. 11). The pits are localized to one region and may have been initiated by small surface inhomogenities. This severe pitting took place after 416 hours in the 600 g/l chloride ion solution, and it can be concluded that pitting is a time-dependent phenomenon and may require surface defects to initiate it. It is noteworthy that the pitting appears to have led ultimately to fracture. Small crystallographic cracks in the corrosion product at the base of a pit appear to be associated with S.C.C. at the base of the pit.

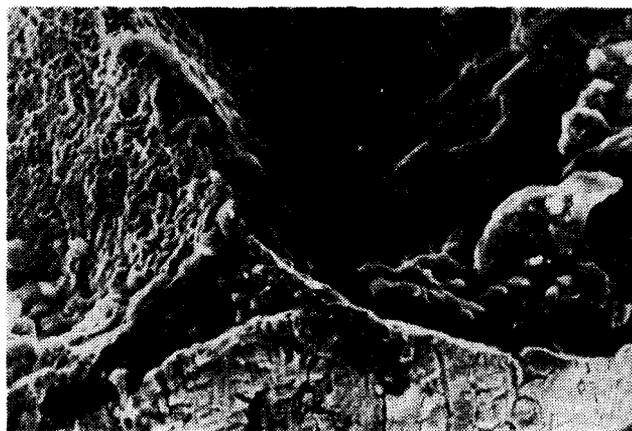
Fig. 12—Ductile-brittle transition region in stainless-steel wire that had been submitted to the modified boiling magnesium chloride test; corrosion product covers the brittle region, and the microscopic voids in the ductile region are visible

required before catastrophic failure takes place are difficult to obtain direct from the fractographs. Fig. 12 shows the detail of the region where the brittle-ductile transition occurs. Since the crack reduces the cross-sectional area of the wire, the area of free surface created determines the point at which ductile fracture occurs. It was calculated that any crack that reduces the area of the wire used from 0,785 mm<sup>2</sup> to 0,602 mm<sup>2</sup> would lead to ductile failure. Many small cracks would be able to achieve this reduction sooner than a single large crack, where crack propagation is controlled largely by electrochemical phenomena.
